1104 & 1106 Alma St. Building Demolition Bid Package

**REPORT OF FACILITY SURVEY TO IDENTIFY
ASBESTOS-CONTAINING MATERIALS AND
LEAD BASED CONTAINING PAINT**

**DEMOLITION OF RESIDENCE
1104 ALMA STREET RESIDENCES
DURHAM, NORTH CAROLINA 27703
EEC JOB NO.: N-23-022**

Subject: **Report of Building Facility Survey to Identify Asbestos-Containing Materials and Lead Based Paint Chips
1104 Alma Street Residences
Demolition Projects
Durham, North Carolina 27703
EEC Job No.: N-23-022**

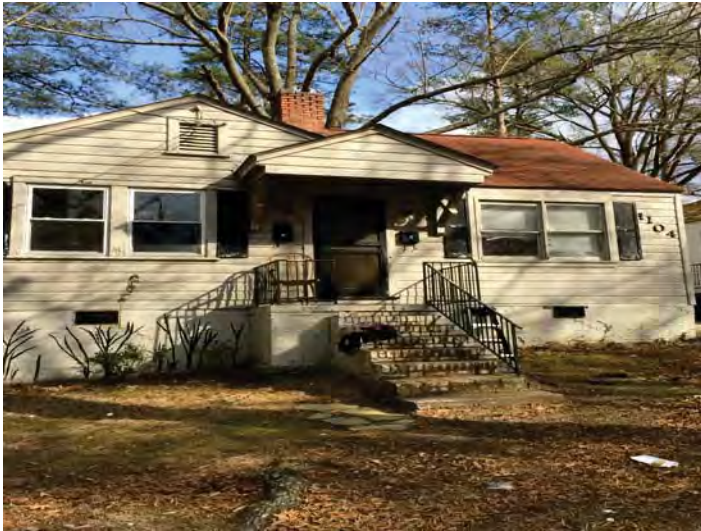
PHOTO No. 1

SAMPLE DESCRIPTION	GENERAL LOCATION	LEAD CONCENTRATION (PERCENT BY WEIGHT)
Sample 104L-11 Gray Paint on Wood	Exterior Wood Siding	6.3%

Typical View of 1104 Alma Street Entry with Gray Paint on Wood Siding

For lead paint removal, if you remove component with lead paint it can be disposed of as construction waste. If you strip paint and repaint, then all waste collected has to be tested to make sure that there is no leachable lead that can enter in to our drinking water. Waste above EPA drinking water standard must be disposed of as hazardous waste. In some cases, it is economical to take the component removed and replaced so less time and cost for construction work in addition to the documentation paperwork and storage of records for a long time.

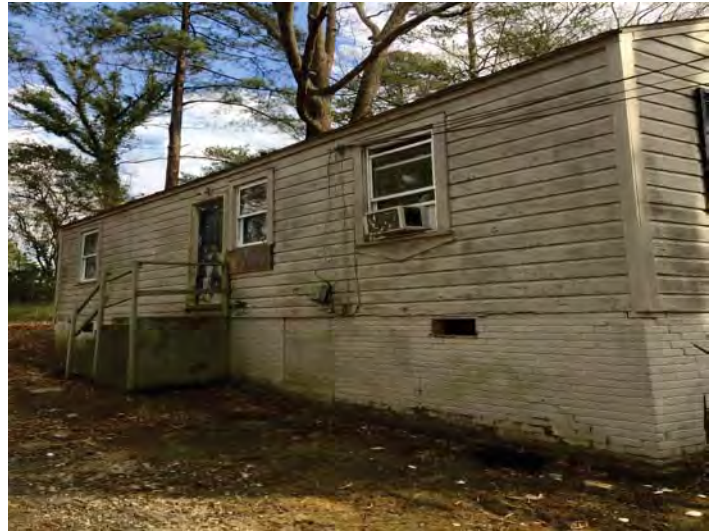
PHOTO No. 2

Typical View of 1104 Alma Street Left Side with Gray Paint on Wood Siding

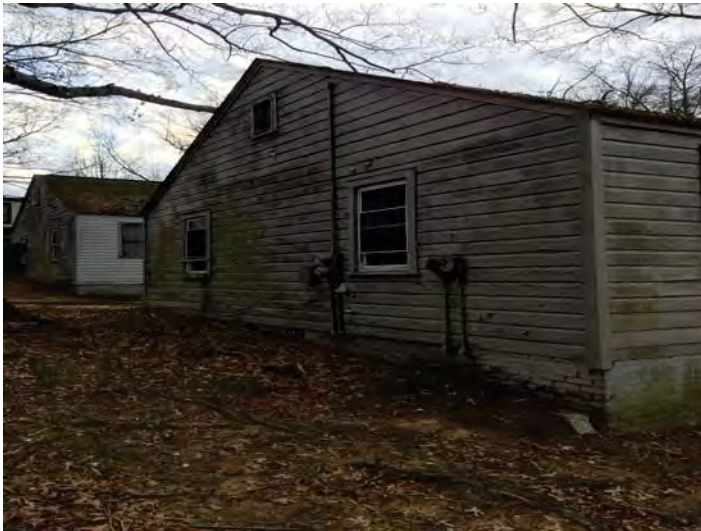
PHOTO No. 3

Typical View of 1104 Alma Street Rear with Gray Paint on Wood Siding

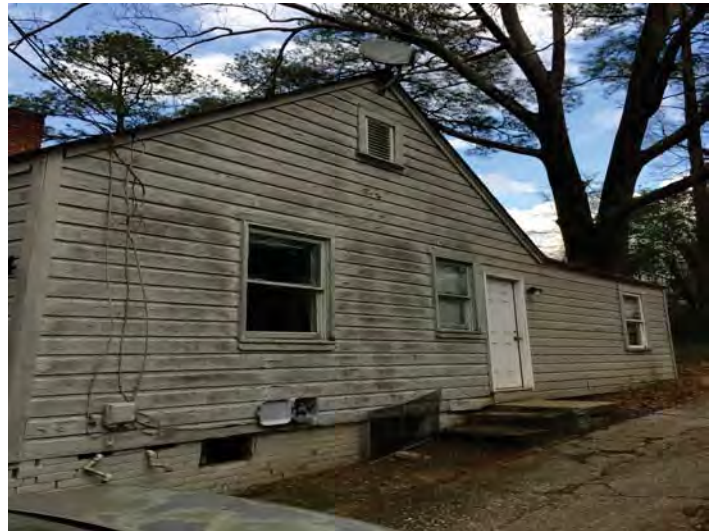
PHOTO No. 4

Typical View of 1104 Alma Street Right Side with Gray Paint on Wood Siding

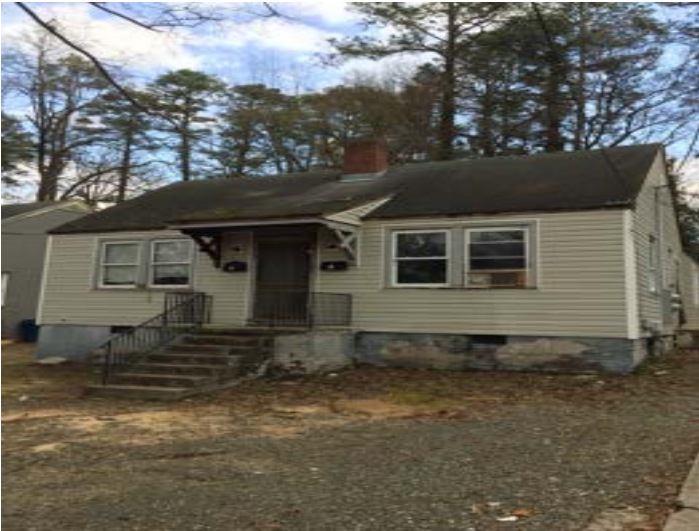
PHOTO No. 1

Typical View of 1106 Alma Street Residence. Exterior has Vinyl Siding

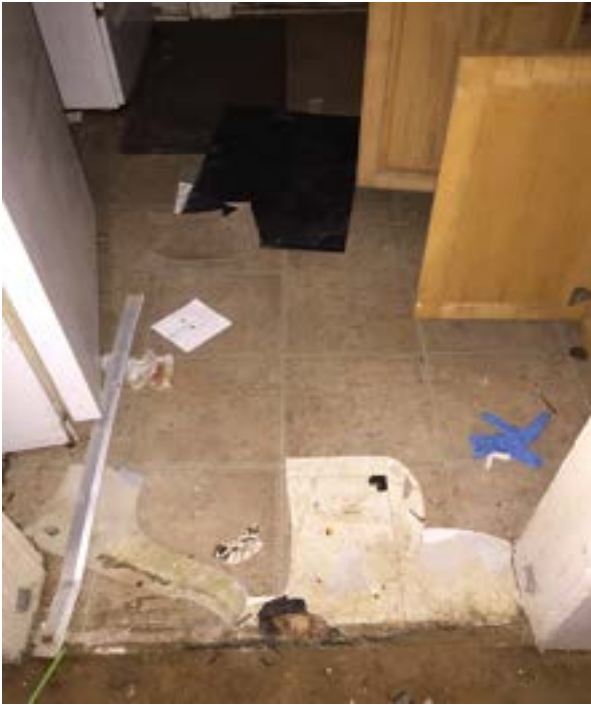
PHOTO No. 5
Typical View of 1106 Alma Street Kitchen Flooring with Multiple Floor Coverings

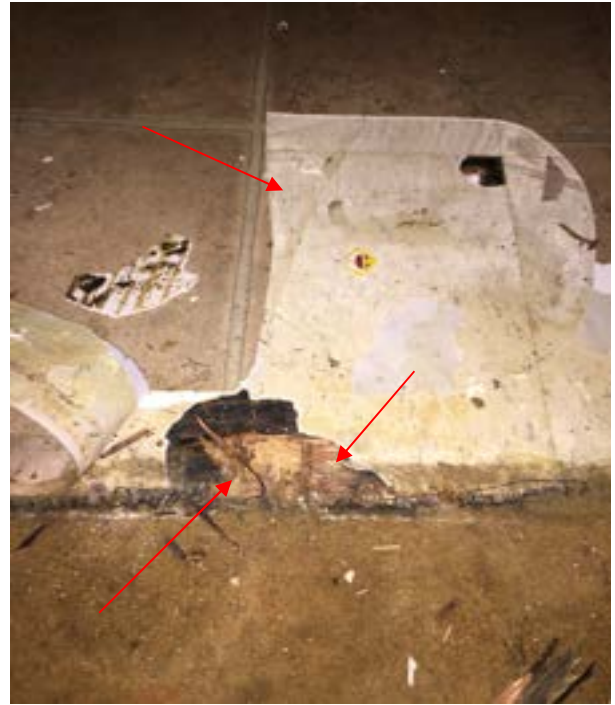
TYPE OF MATERIAL	GENERAL LOCATION*	TYPE OF ASBESTOS AND PERCENTAGE	ESTIMATED QUANTITY
Black Mastic	1106 Alma Street Unit A- Kitchen Bottom Layer Under Linoleum and Floor Tile	2% Chrysotile	64 square feet (sq. ft)

ACM was identified in the bulk sample collected in the Kitchen in the 1106 Alma Street residence. The identified ACM black floor mastic is located below a layer of linoleum, one layer of floor tile and below a layer of plywood sheathing adhered to a layer of floor tile. Before any demolition or renovations are conducted where ACM was detected, these items must be removed in compliance with EPA NESHAP (National Emission Standard for Hazardous Air Pollutants) regulations. The State of North Carolina will require a permit before removal and demolition, which will include removal of asbestos from the work area if more than 160 square feet or 260 linear feet of asbestos is removed. Also, a demolition permit will be required whenever any demolition is performed from City of Durham. It will require 10 days of notice time before the demolition or abatement can be initiated.

PHOTO No. 6
Typical View of Positive Black Mastic Below the Layers of Flooring. Top: Brown Linoleum, Second Layer White Floor Tile, Third Layer Plywood, Fourth Layer Floor Tile and Black Mastic

Bidders must provide an “Add Alternate” pricing to include removal of 64 sf of ACMs as described below, and shown in the attachment “Final Survey Report_1106 Alma Street”.
